Manhole Inspection Summary

Manhole # S35WW1026MH

Location Address: **5202 TILBURY WAY**

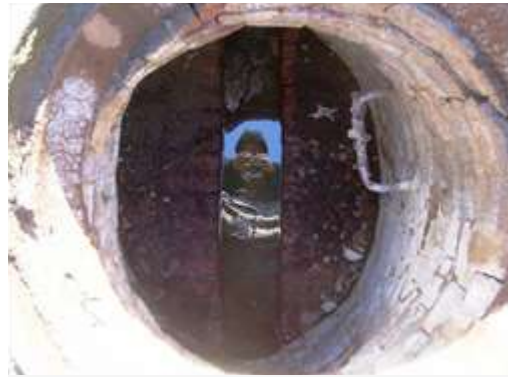
Top View

Evidence of surcharge - Bench debris.
Channel debris.

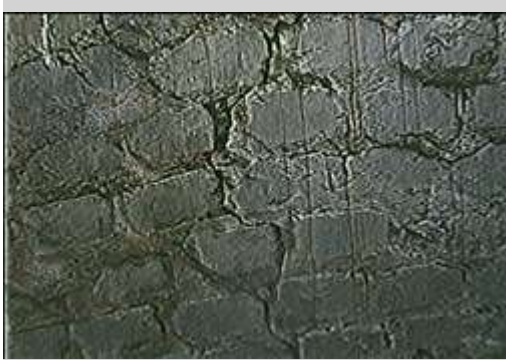
Defect

Barrel deterioration and infiltration.

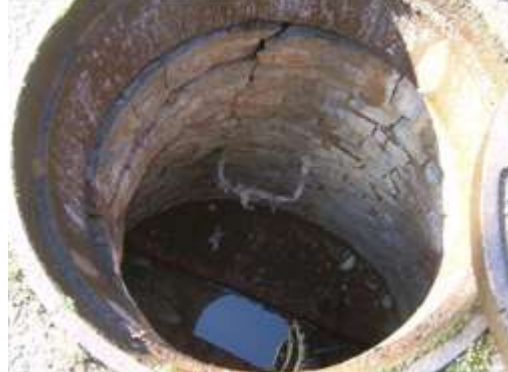
Defect

Frame leaks. Frame offset. Adjustment
deterioration, loose brick, cracks and
infiltration. Corbel and Barrel infiltration.

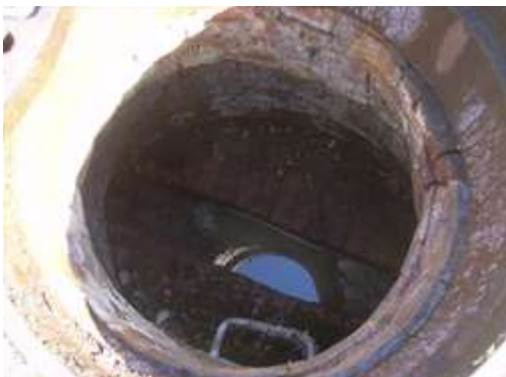
Defect

Frame leaks. Frame offset. Adjustment
deterioration, loose brick and infiltration.
Corbel and Barrel infiltration.

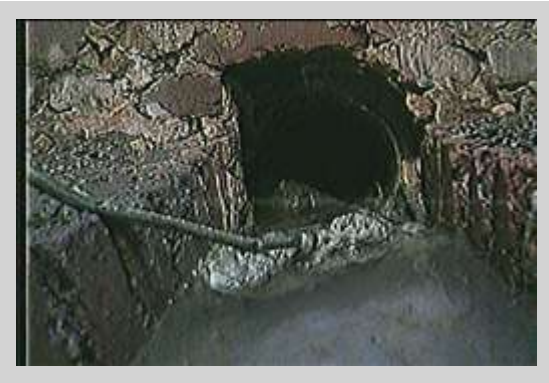
8 in. Circular Gravity Sewer Pipe Out @ 12 O'Clock

Deposits: ☐ None ☒ **Mud** ☐ Sludge ☒ **Debris** ☐ Grease

Silt Depth: **2** (in.) Deposits Extent: **Light**

Infiltration: **Evidence** Pipe Seal Cond: **Broken**

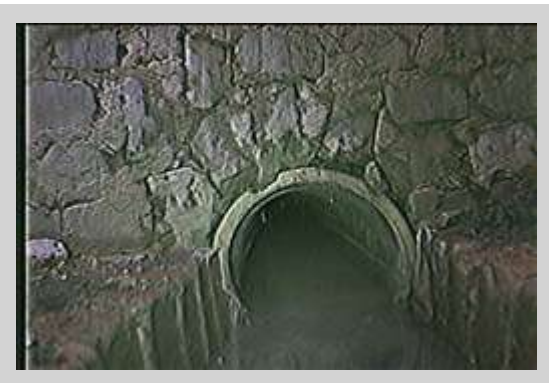
8 in. Circular Gravity Sewer Pipe In @ 6 O'Clock

Barrel deterioration and infiltration. Channel deterioration.

Deposits: ☐ None ☒ **Mud** ☐ Sludge ☒ **Debris** ☐ Grease

Silt Depth: **2** (in.) Deposits Extent: **Light**

Infiltration: **Evidence** Pipe Seal Cond: **Cracked**
